PROPERTY CONDITION REPORT

CLIENT: Joe Howell
PROPERTY ADDRESS: 210 N 32nd Ave
Omaha NE
AGENT: Morrie Korthals
DATE: 1/28/2014
INSPECTOR: Adam Staab
REPORT #: 210_4

Report# 210_4
210 N 32nd Ave
Omaha NE
Dear Joe,

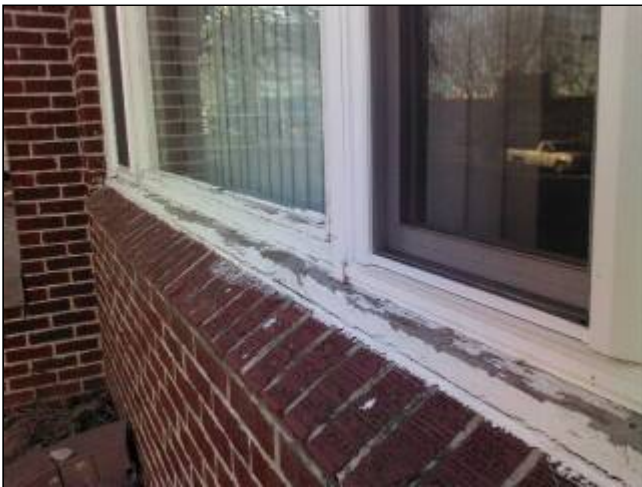
2.3 1

Peeling paint at various window trims around building.. Recommend properly prepping and painting to extend useful life of underlying framing areas. No underlying damages visible during time of inspection.

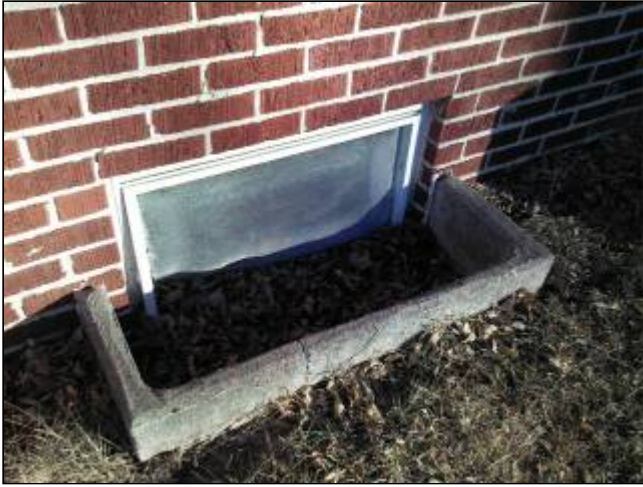
2.4 1

Window wells missing covers and are full of dirt and debris. Recommend installing covers after clearing out and ensuring grading is at least 6" below sill to reduce possibility of moisture intrusion into basement. None visible at within basement during time of inspection.

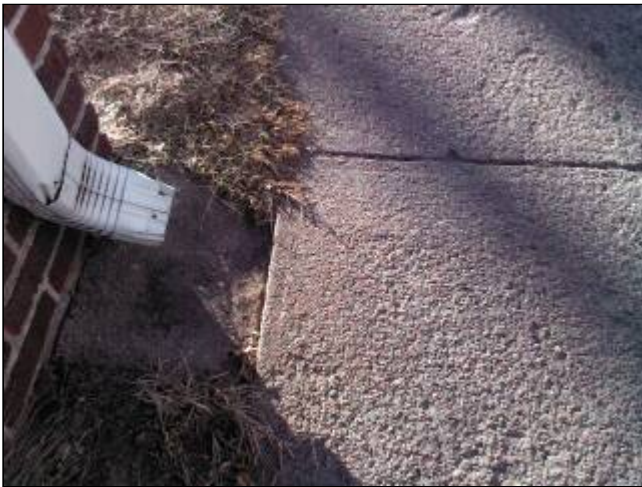
3.0 1

Recommend extending downspouts along foundation wall around building at least 6' away from foundation wall to avoid possibility of moisture penetration and associated damages. None visible beneath area during time of inspection.

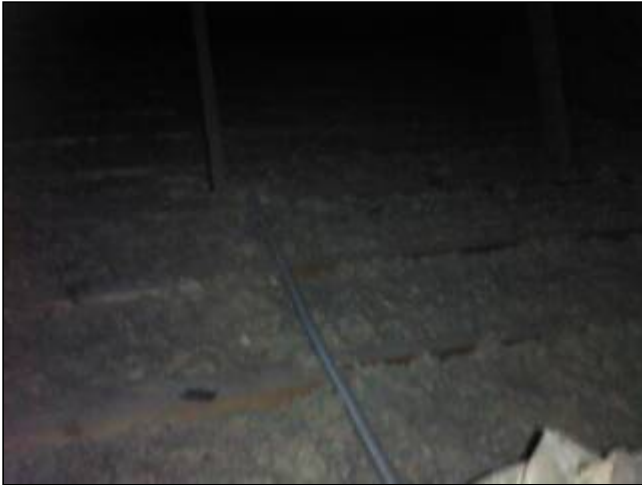
5.1 1

6 -8 inches of Blown Fiberglass insulation present. U.S. Department of Energy recommends R-38 rating in attic spaces, which equates to 14-17 inches. Consider providing additional depth to maintain intended energy efficiency to home and reduce associated fuel costs.

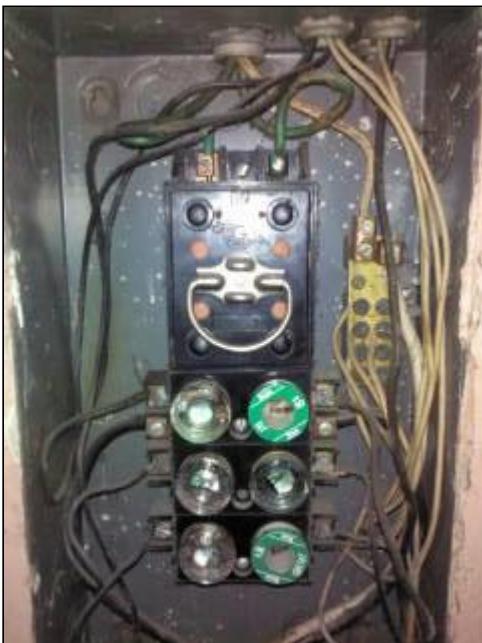
6.1 1

Open view of fuse panel. Units have 60-Amp service. This is inadequate for the electrical distribution demands of today's modern homes and presents an obstacle in obtaining homeowners insurance since most providers require a minimum of 100-Amp service. Contract licensed electrician to thoroughly evaluate system and properly upgrade service to home to provide for safe and proper electrical distribution. This upgrade may also involve the upgrading of the service drop conductors from the service point at the mast (the electrical wires coming into the home from the outside).

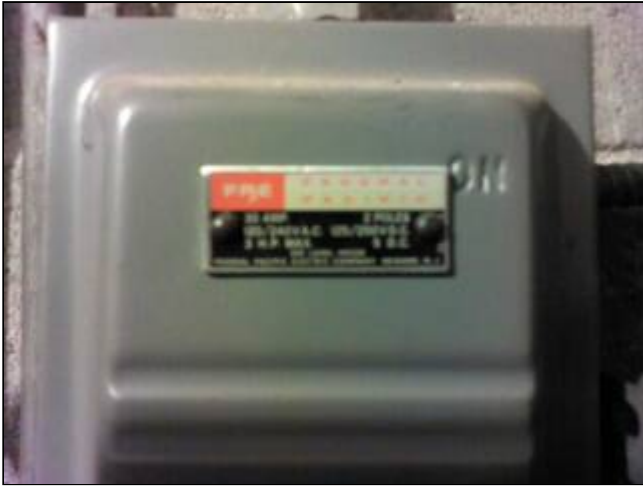
6.4 1

Distribution panel was manufactured by Federal Pacific Electric, whose products have a history of problems such as loose circuit breakers arcing and catching fire, breaker failure, and breakers failing to trip when required. Exercise caution when removing dead front cover since doing so will cause breakers to be disturbed and possibly trip (another design fault) since their "on" position breaks the threshold of the cover. Contract licensed electrician to thoroughly inspect and replace to ensure safe access and operation is maintained, particularly when maintenance or repairs are necessary. See <http://inspect-ny.com/fpe/fpepanel.htm> for more information.

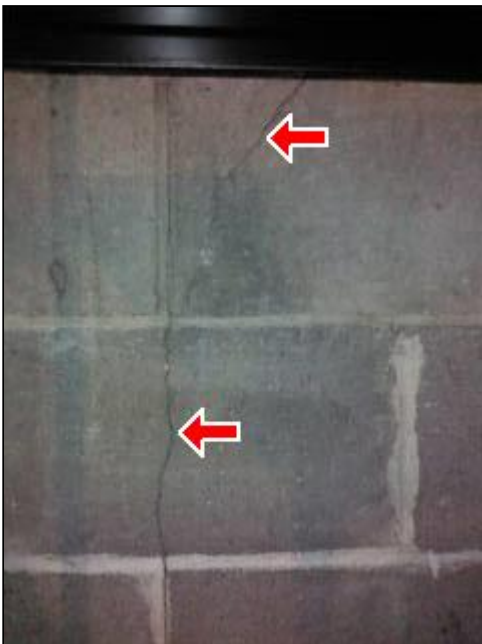
7.2 1

Minor Settlement cracking visible at foundation wall of North side utility room. No previous repairs made and no signs of recent movement. Recommend sealing to monitor for future movement and associated damages. No associated structural damages visible during time of inspection.

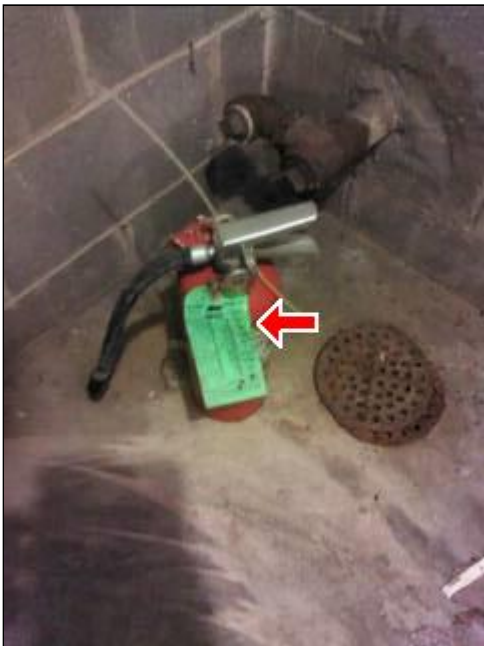
7.13 1

Fire extinguishers throughout building hallway safety inspection logs are outdated. This is unsafe, as they must be treated every year, especially in a multi unit complex. Recommend having all extinguishers tested and placed in proper case on walls. Inadequate number of smoke detectors installed in home. Smoke detectors should be located in all bedrooms, hallways, and rooms. Also, a CO detector should be installed in same space as all fuel-burning appliances (not directly above or beside units since it is normal for them to emit a small amount of carbon monoxide upon start-up) and in all upper-level hallways. Recommend installing to provide necessary early smoke/CO detection to home. For more detailed information, please refer to support documentation attached to bottom of report.

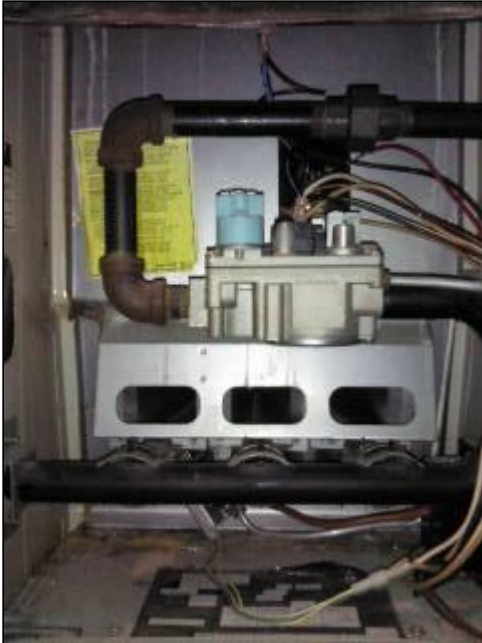
8.1 1 unit #1 serial #5188A00192

View of open furnace burner areas. Furnace units are 26 years old (expected life is 20-22 years) and display rust and corrosion in burner/blower/heat exchanger areas. Unable to determine extent of underlying damages, but units perform as intended during time of inspection. Recommend having units serviced prior to closing and maintaining annual service to maximize useful life and maintain system efficiency. Budget for future replacement.

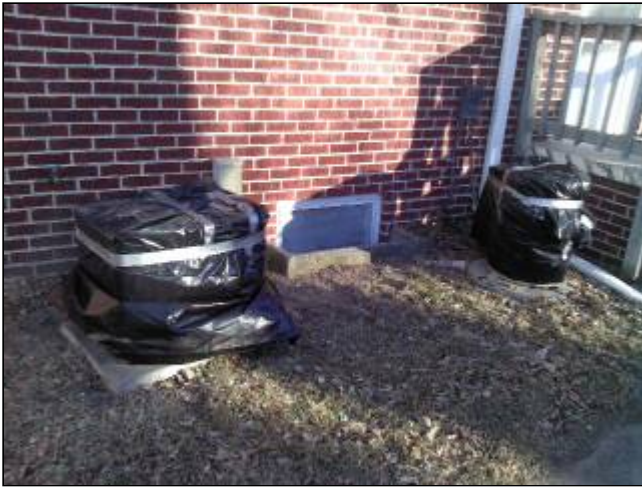
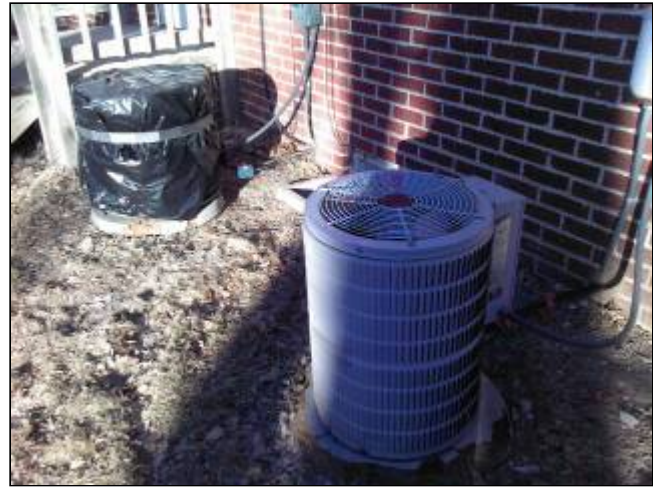
Outdoor temperature has been less than 60 degrees within the last 24 hours, preventing safe operation of A/C system (turning on A/C in cold weather may damage internal components). Unable to visually verify components condition. Due to age of furnace units, Recommend having unit maintenance performed to ensure maximum efficiency and useful life. Units concealed, unable to determine mfg date. Only open unit is 1988. Budget for future replacement.

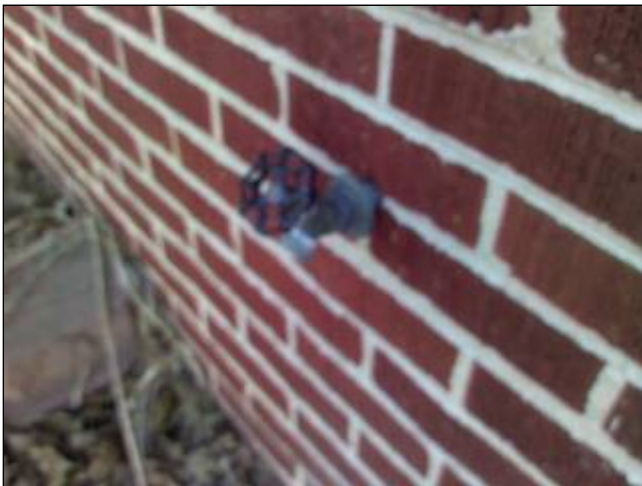
10.2 1

Hose bibs secured at basement. Unable to determine cause or test/inspect. Recommend investigating and correcting to restore proper function.

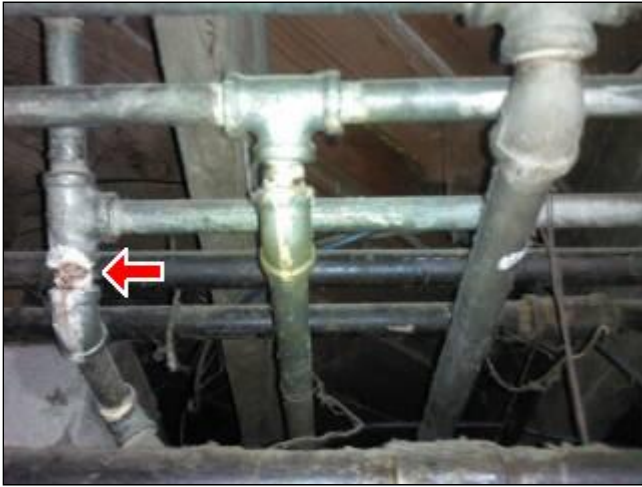
10.3 1

Majority of distribution piping is of galvanized steel construction. Typically, over time this piping will have its water flow reduced by corrosion build-up and leaking joints. None visible during time of inspection. Recommend contracting licensed plumber to evaluate and repair/replace areas as necessary to facilitate proper system performance and increase safe water usage.

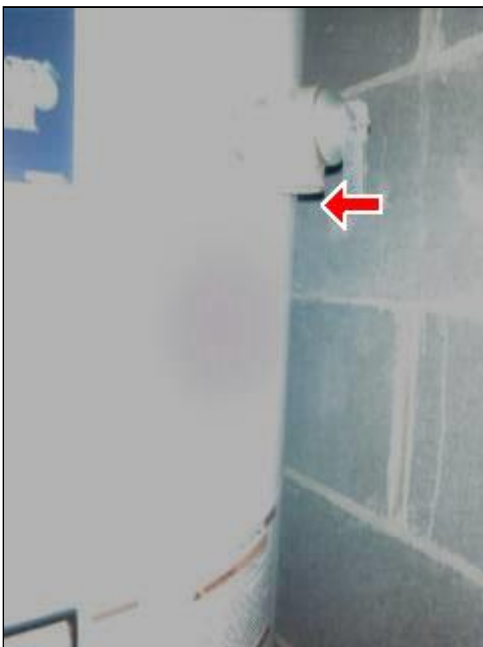
(1) Temperature valve broken at unit # 1 Drip tube is missing for units # 1 and #2 Recommend installing and terminating within 6" above floor to reduce associated personal injury hazards if T&P relief valve were to discharge.

10.6 1 units missing drip tubes

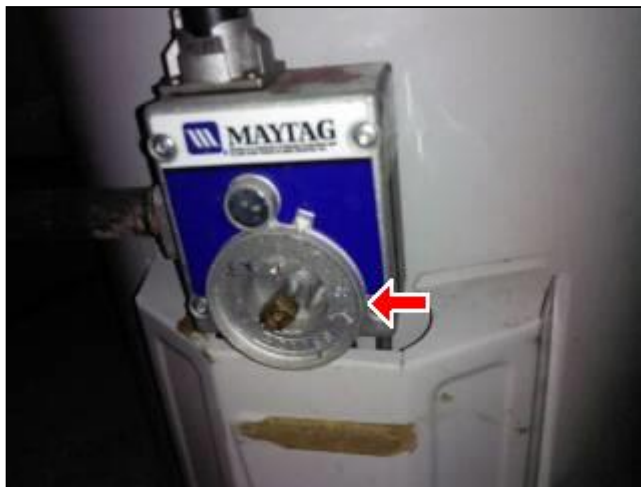
10.6 2 unit #1 missing temp control

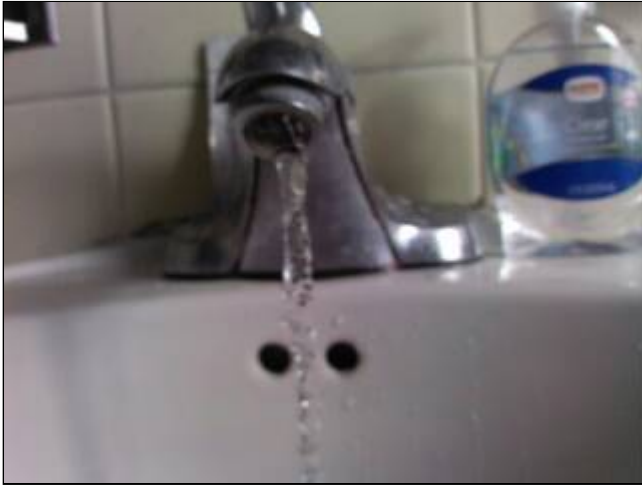
11.0 1

Low flow noted in all units. (pressure most likely due to mineral build up in piping). This condition may be caused by installed Galvanized piping system. Recommend contracting licensed plumber to thoroughly investigate and replace galvanized areas as necessary, including plumbing section coming in from curb stop, to restore proper system performance.

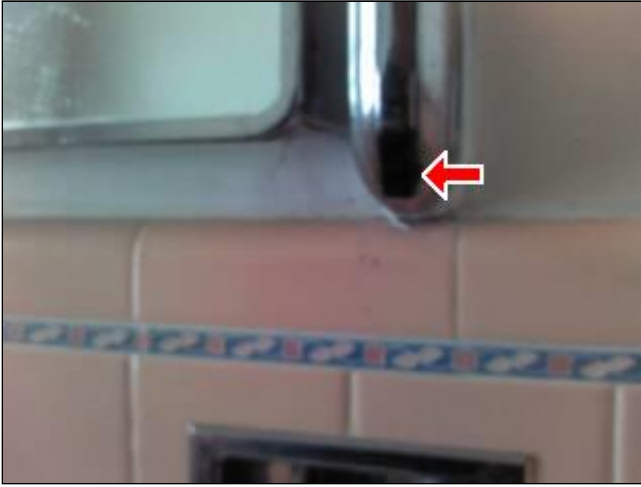
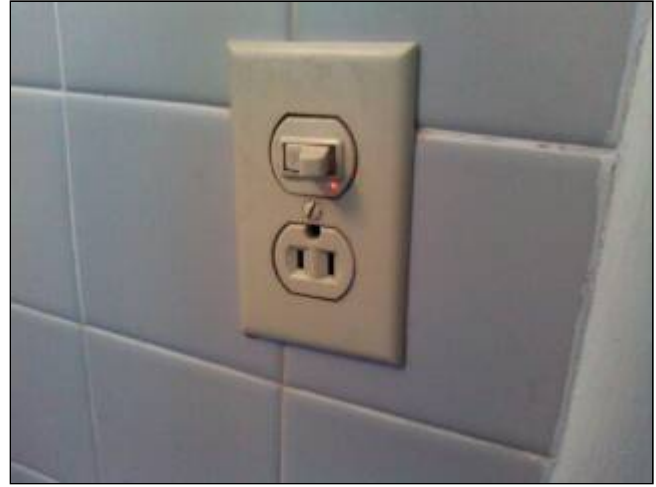
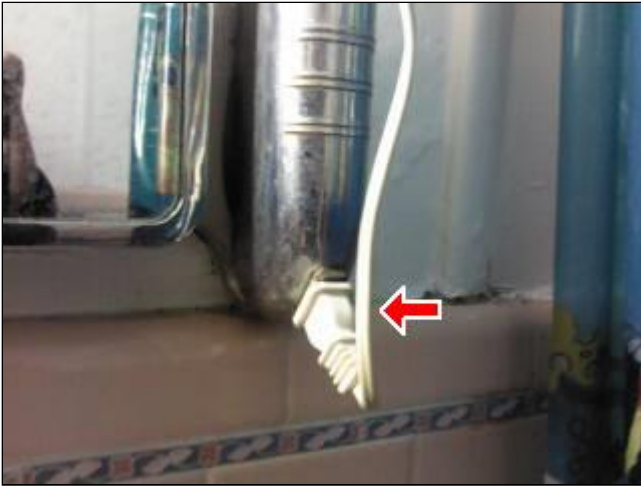
No GFCI protection present at bathrooms; Ground Fault Circuit Interrupters should be installed in all kitchens, bathrooms, garage outlets, exterior outlets, and in unfinished basements. Recommend contracting licensed electrician to install to protect occupants from electrical shock during a fault situation.

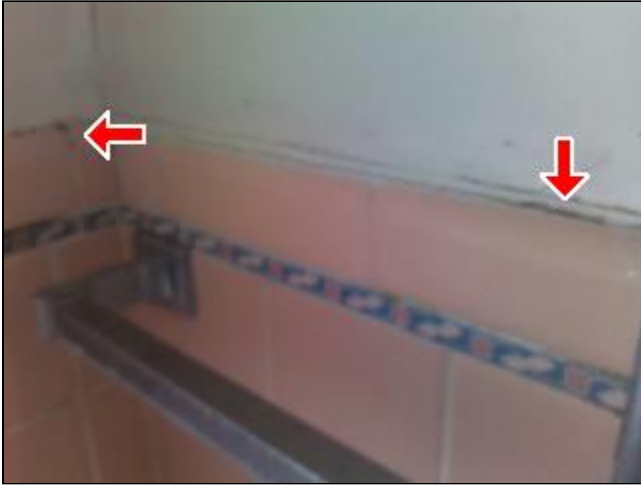
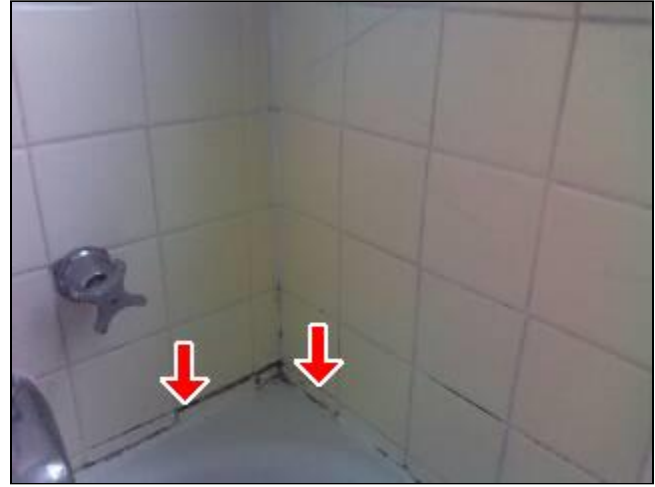
Deteriorated caulking at ceramic tiles within showers throughout units. This will allow water to penetrate underlying framing areas and spread associated damages. Recommend removing deteriorated caulking and properly re-caulking to reduce possible moisture penetration and associated damages. None visible during time of inspection.

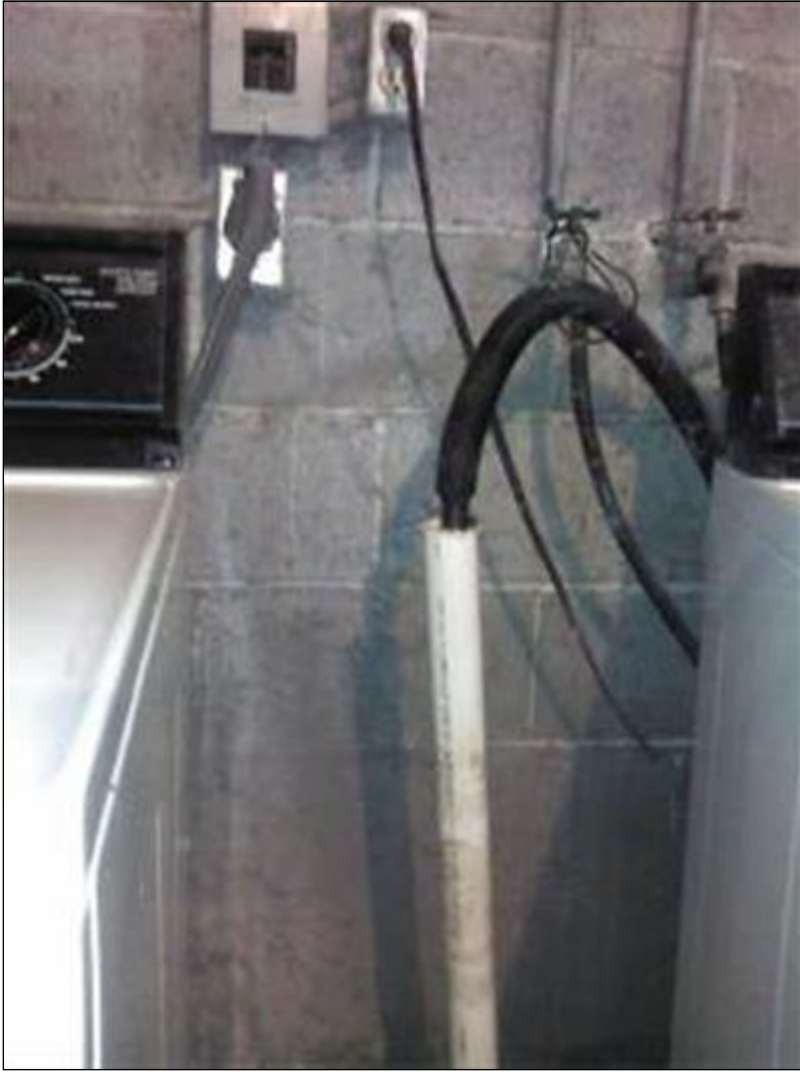
12.9 1

Dryer vent terminates into basement and has sprayed lint into space. This is improper and unsafe since lint creates a fire hazard. Vent should properly terminate to exterior. Recommend correcting to reduce associated damages.

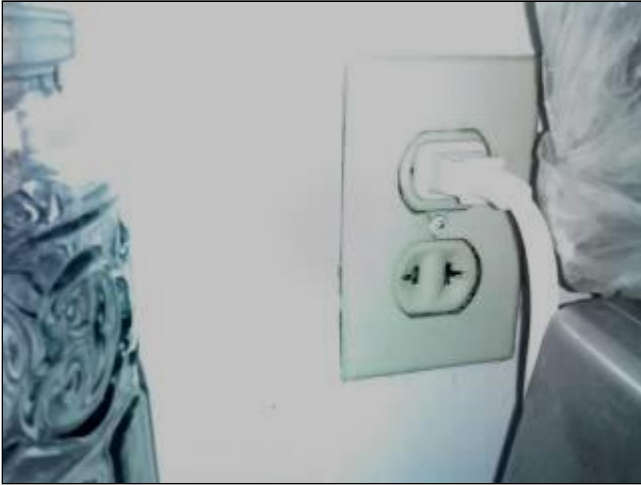
13.8 1

No GFCI protection present at kitchens.. Ground Fault Circuit Interrupters should be installed in all kitchens, bathrooms, garage outlets, exterior outlets, and in unfinished basements. Recommend contracting licensed electrician to install to protect occupants from electrical shock during a fault situation.

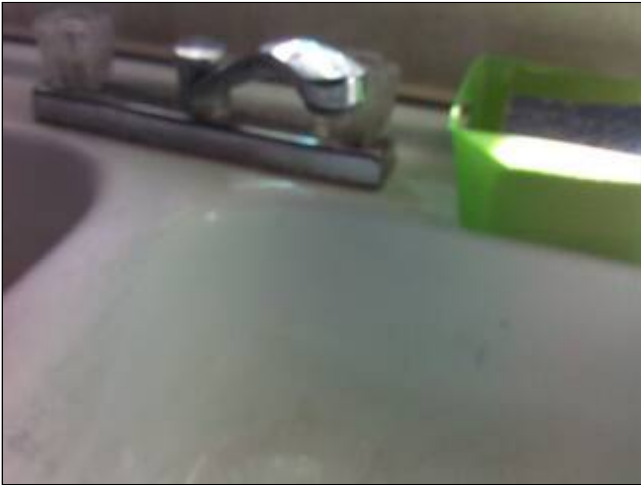
13.9 1

Sink at unit #3 has drip. Recommend repairing/replacing to ensure proper performance and efficiency.

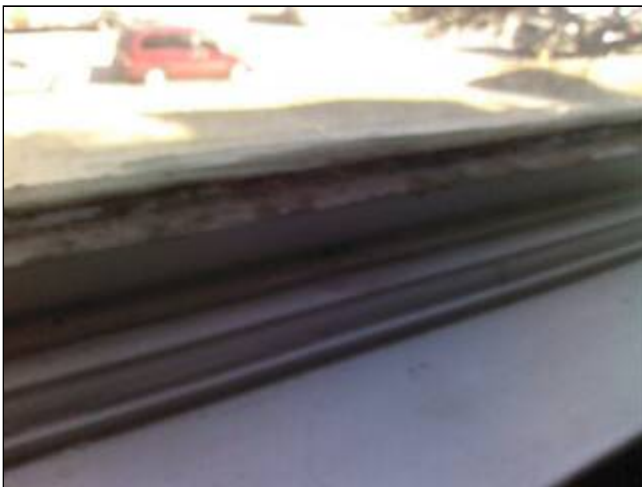
14.3 1

East windows, and windows throughout property have peeling paint at trims and sills. Recommend properly prepping and painting to extend life of underlying framing areas. No damages visible during time of inspection.

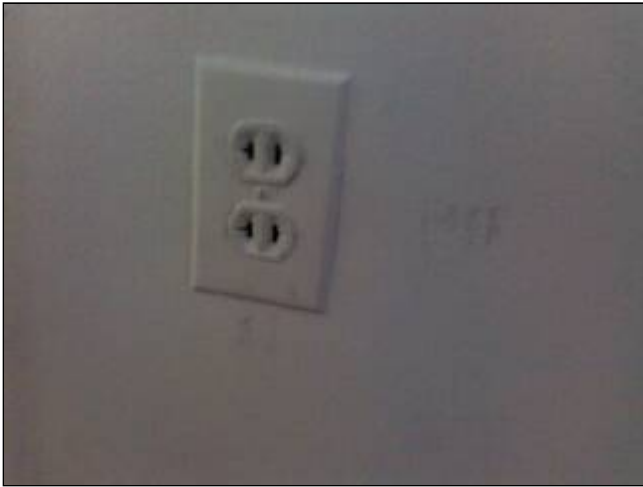
14.8 1

Electrical outlets ungrounded. Unable to test.

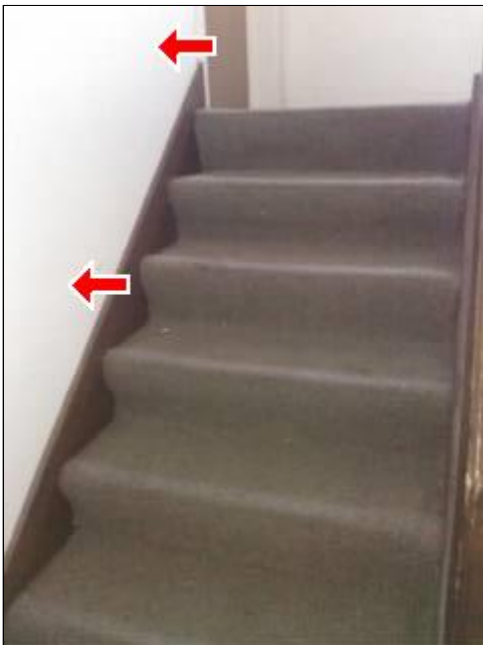
23.9 1

Missing handrails at entryway and back steps. This is a liability issue in common areas. Handrails necessary when 3 or more steps are present. Recommend adding to provide necessary stability during use, particularly during winter weather.

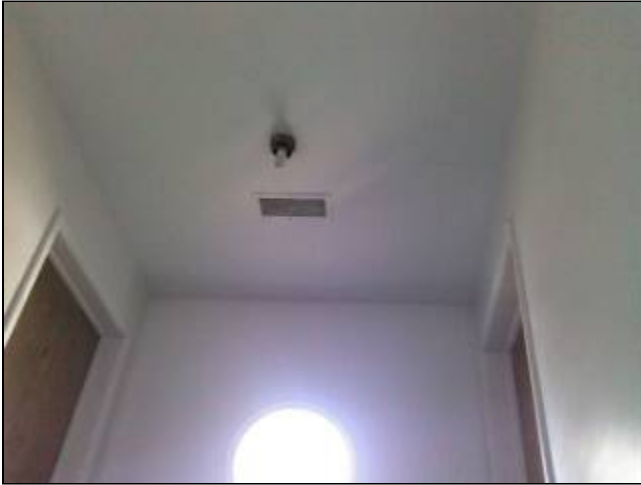
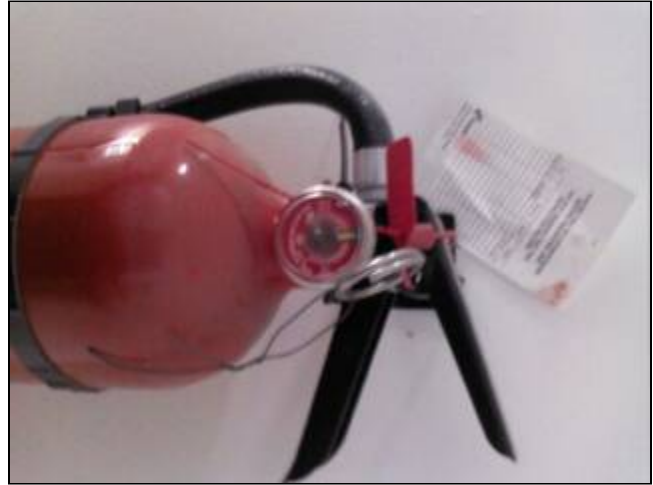
No working smoke detectors within hallway during time of inspection. Unable to determine cause. Recommend installing to correct to restore early smoke detection. Fire extinguishers throughout building hallway safety inspection logs are outdated. This is unsafe, as they must be treated every year, especially in a multi unit complex. Recommend having all extinguishers tested and placed in proper case on walls.

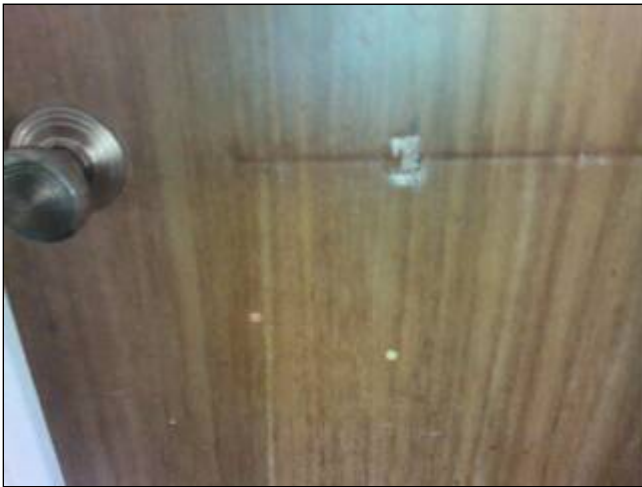
24.4 1

Damaged closet door at unit 3.

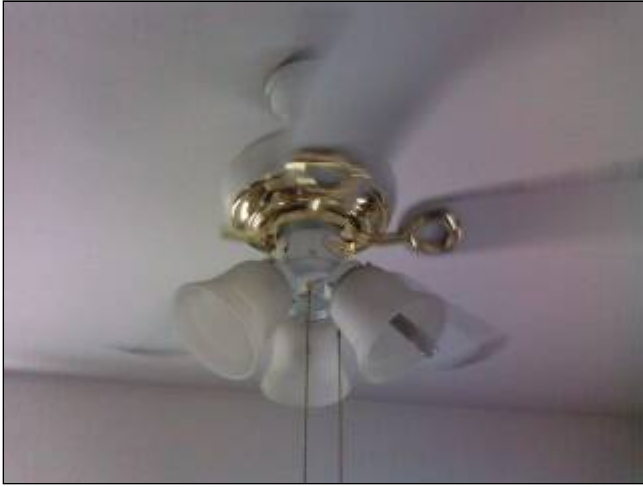
24.8 1

Ceiling fan is noisy in vacant unit #2. Recommend repair/replacement to provide safe and proper operation.

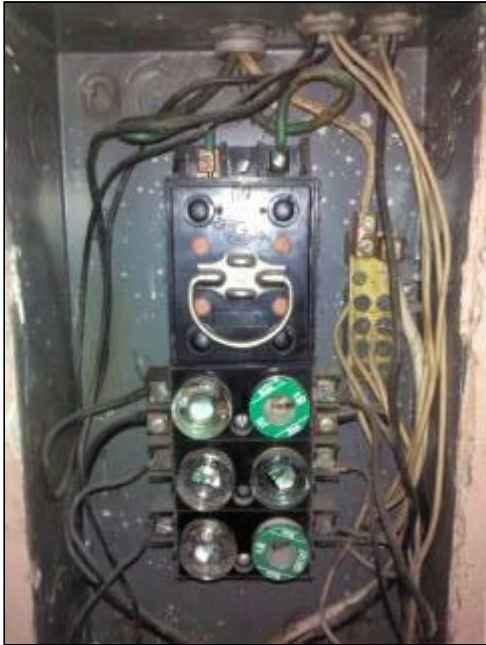
6.1 Picture 1

Open view of fuse panel. Units have 60-Amp service. This is inadequate for the electrical distribution demands of today's modern homes and presents an obstacle in obtaining homeowners insurance since most providers require a minimum of 100-Amp service. Contract licensed electrician to thoroughly evaluate system and properly upgrade service to home to provide for safe and proper electrical distribution. This upgrade may also involve the upgrading of the service drop conductors from the service point at the mast (the electrical wires coming into the home from the outside).

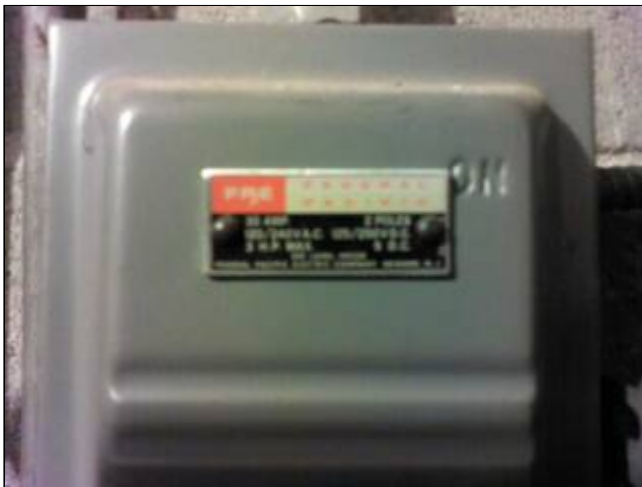
6.4 Picture 1

Distribution panel was manufactured by Federal Pacific Electric, whose products have a history of problems such as loose circuit breakers arcing and catching fire, breaker failure, and breakers failing to trip when required. Exercise caution when removing dead front cover since doing so will cause breakers to be disturbed and possibly trip (another design fault) since their "on" position breaks the threshold of the cover. Contract licensed electrician to thoroughly inspect and replace to ensure safe access and operation is maintained, particularly when maintenance or repairs are necessary. See <http://inspect-ny.com/fpe/fpepanel.htm> for more information.

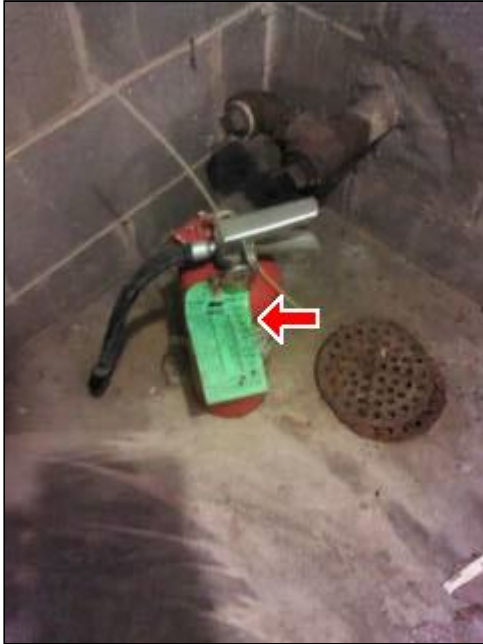
7.13 Picture 1

Fire extinguishers throughout building hallway safety inspection logs are outdated. This is unsafe, as they must be treated every year, especially in a multi unit complex. Recommend having all extinguishers tested and placed in proper case on walls. Inadequate number of smoke detectors installed in home. Smoke detectors should be located in all bedrooms, hallways, and rooms. Also, a CO detector should be installed in same space as all fuel-burning appliances (not directly above or beside units since it is normal for them to emit a small amount of carbon monoxide upon start-up) and in all upper-level hallways. Recommend installing to provide necessary early smoke/CO detection to home. For more detailed information, please refer to support documentation attached to bottom of report.

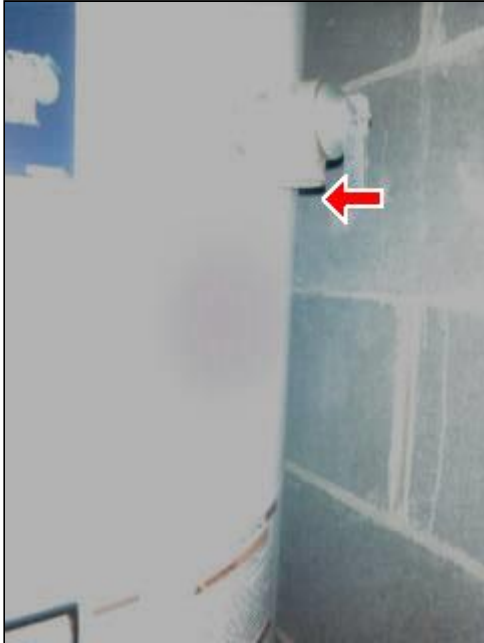
(1) Temperature valve broken at unit # 1 Drip tube is missing for units # 1 and #2 Recommend installing and terminating within 6" above floor to reduce associated personal injury hazards if T&P relief valve were to discharge.

10.6 Picture 1 units missing drip tubes

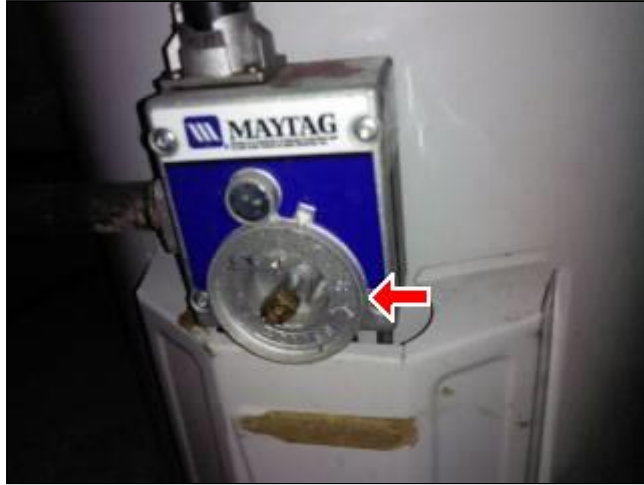
10.6 Picture 2 unit #1 missing temp control

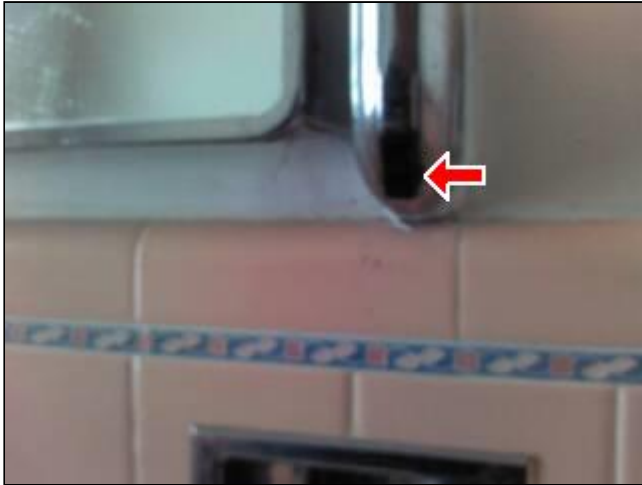
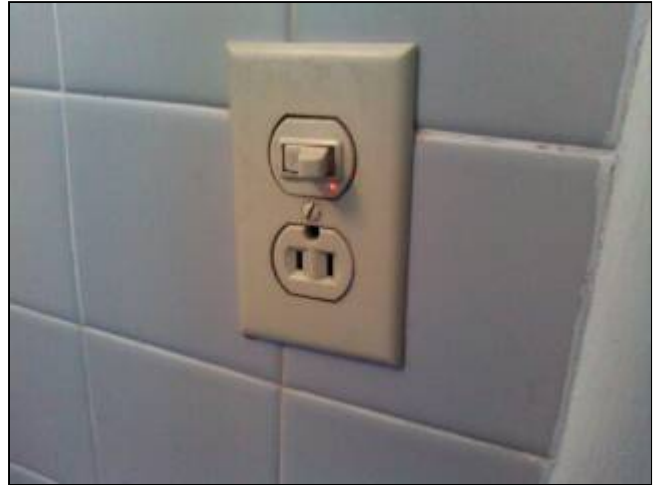
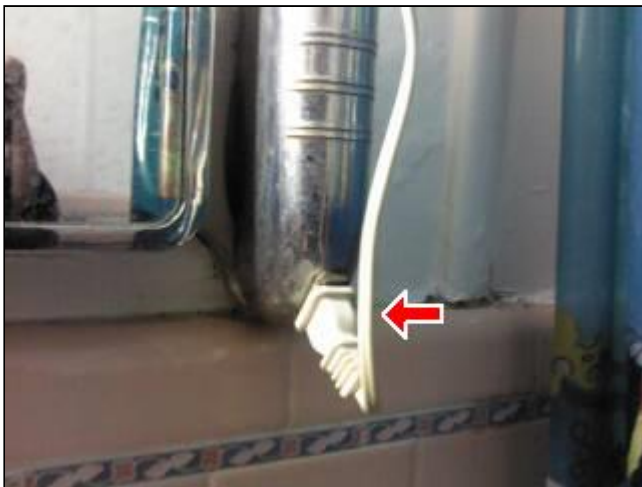
No GFCI protection present at bathrooms; Ground Fault Circuit Interrupters should be installed in all kitchens, bathrooms, garage outlets, exterior outlets, and in unfinished basements. Recommend contracting licensed electrician to install to protect occupants from electrical shock during a fault situation.

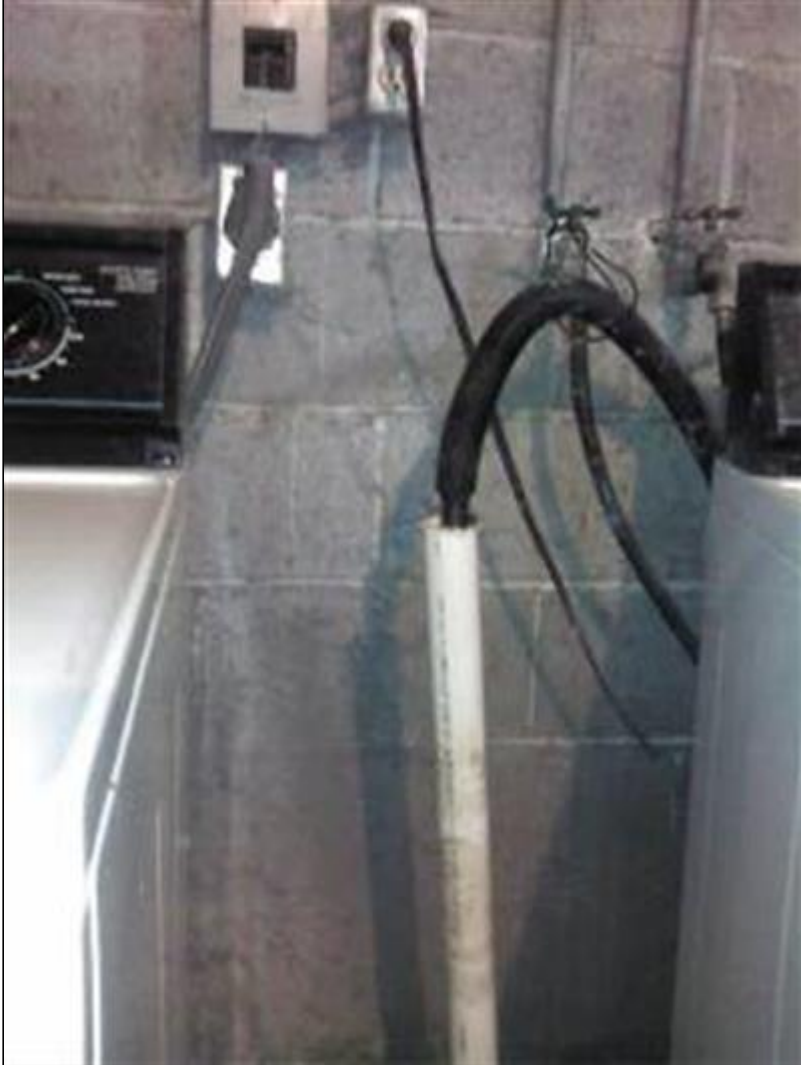
12.9 Picture 1

Dryer vent terminates into basement and has sprayed lint into space. This is improper and unsafe since lint creates a fire hazard. Vent should properly terminate to exterior. Recommend correcting to reduce associated damages.

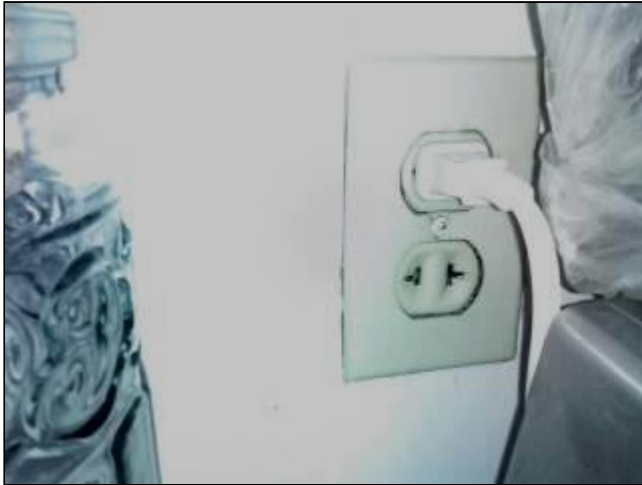
13.8 Picture 1

No GFCI protection present at kitchens.. Ground Fault Circuit Interrupters should be installed in all kitchens, bathrooms, garage outlets, exterior outlets, and in unfinished basements. Recommend contracting licensed electrician to install to protect occupants from electrical shock during a fault situation.

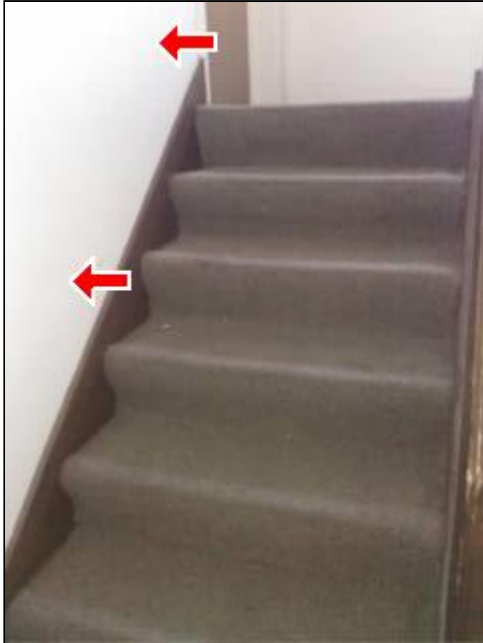
23.9 Picture 1

Missing handrails at entryway and back steps. This is a liability issue in common areas. Handrails necessary when 3 or more steps are present. Recommend adding to provide necessary stability during use, particularly during winter weather.

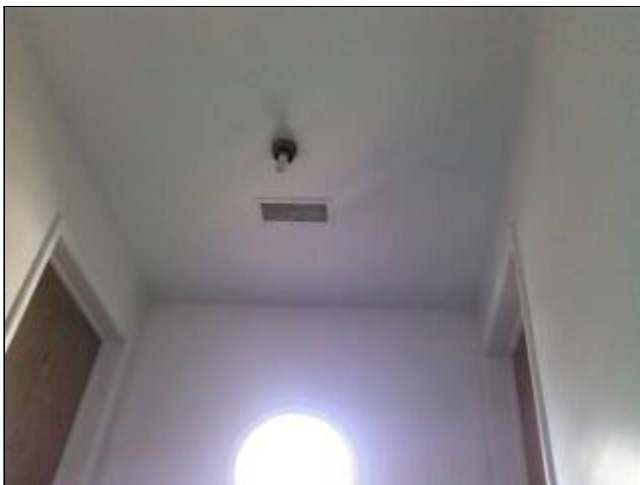
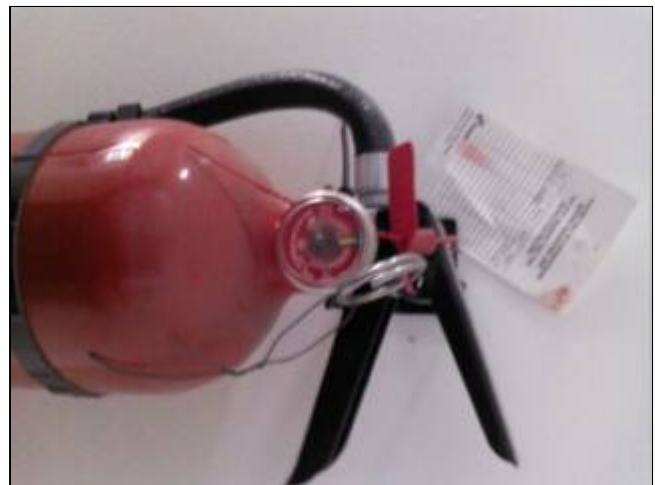
No working smoke detectors within hallway during time of inspection. Unable to determine cause. Recommend installing to correct to restore early smoke detection. Fire extinguishers throughout building hallway safety inspection logs are outdated. This is unsafe, as they must be treated every year, especially in a multi unit complex. Recommend having all extinguishers tested and placed in proper case on walls.

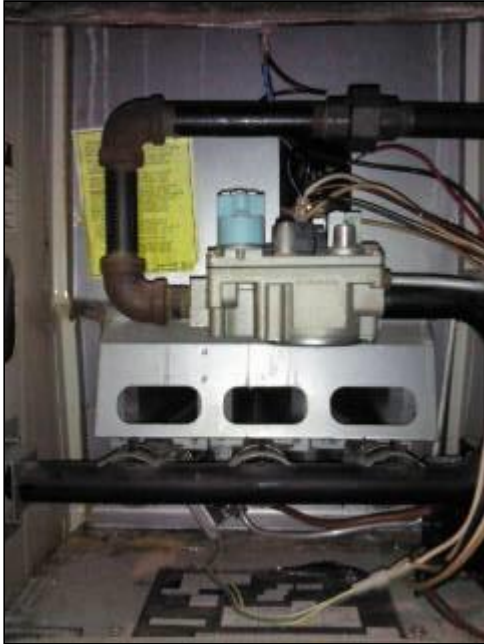
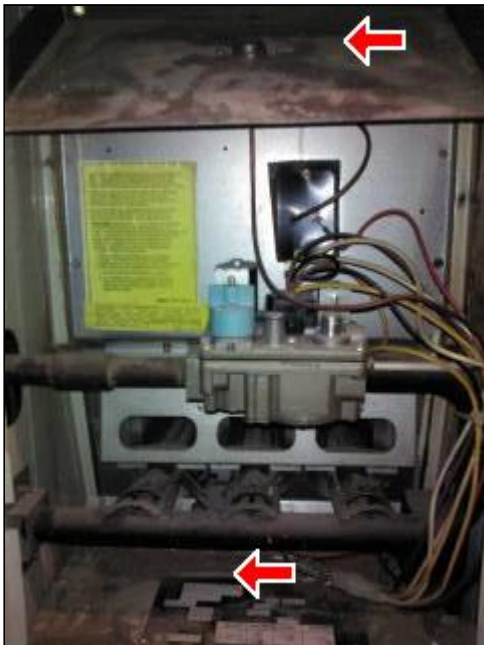
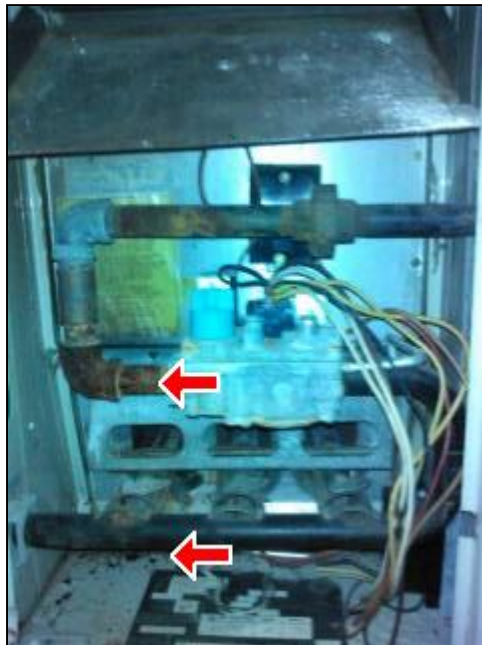
View of open furnace burner areas. Furnace units are 26 years old (expected life is 20-22 years) and display rust and corrosion in burner/blower/heat exchanger areas. Unable to determine extent of underlying damages, but units perform as intended during time of inspection. Recommend having units serviced prior to closing and maintaining annual service to maximize useful life and maintain system efficiency. Budget for future replacement.

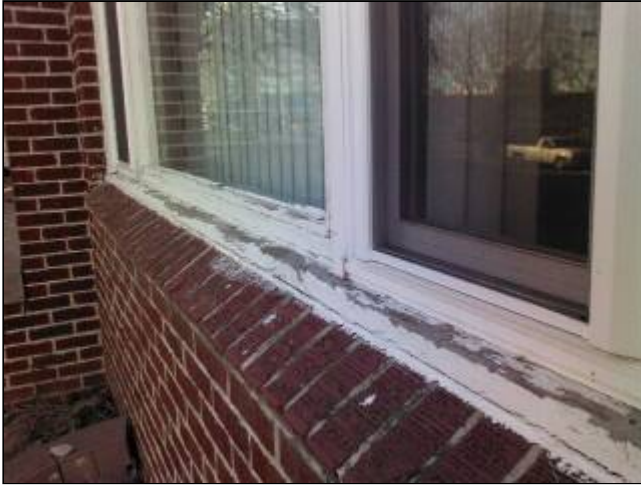
2.3 Picture 1

Peeling paint at various window trims around building.. Recommend properly prepping and painting to extend useful life of underlying framing areas. No underlying damages visible during time of inspection.

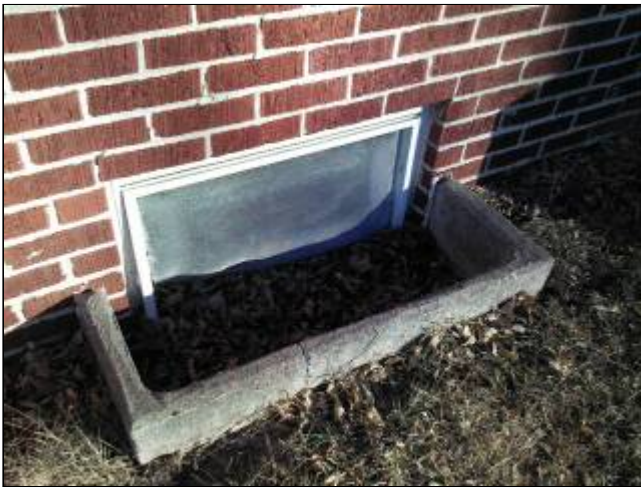
2.4 Picture 1

Window wells missing covers and are full of dirt and debris. Recommend installing covers after clearing out and ensuring grading is at least 6" below sill to reduce possibility of moisture intrusion into basement. None visible at within basement during time of inspection.

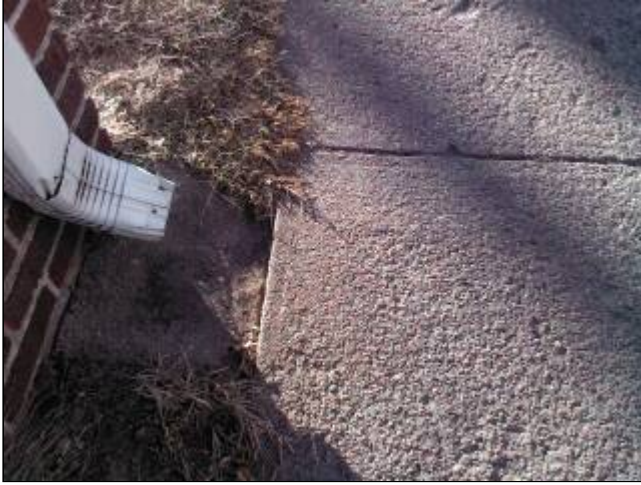
3.0 Picture 1

Recommend extending downspouts along foundation wall around building at least 6' away from foundation wall to avoid possibility of moisture penetration and associated damages. None visible beneath area during time of inspection.

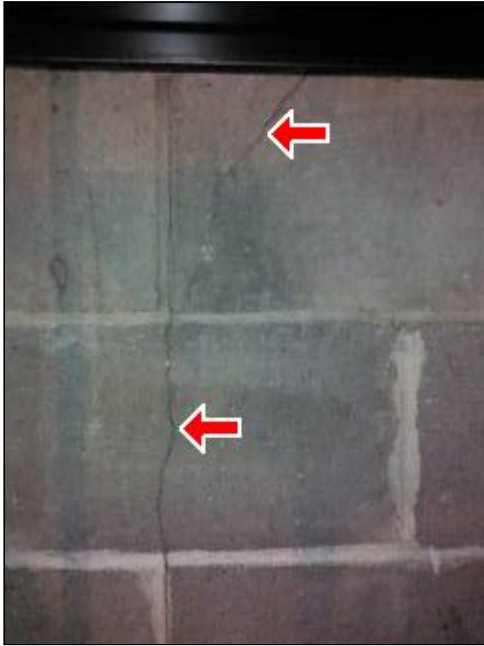
7.2 Picture 1

Minor Settlement cracking visible at foundation wall of North side utility room. No previous repairs made and no signs of recent movement. Recommend sealing to monitor for future movement and associated damages. No associated structural damages visible during time of inspection.

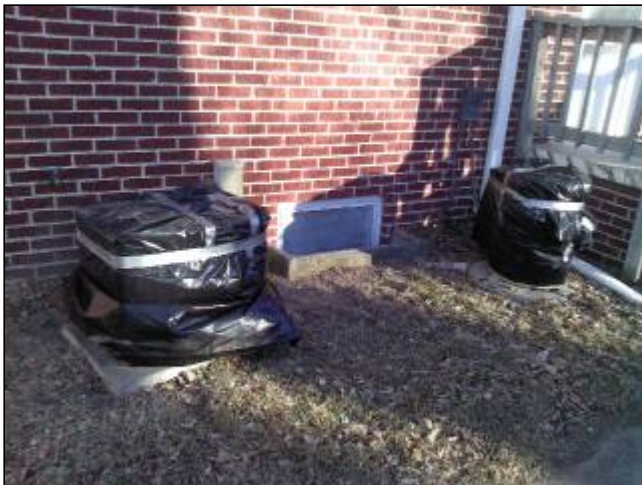
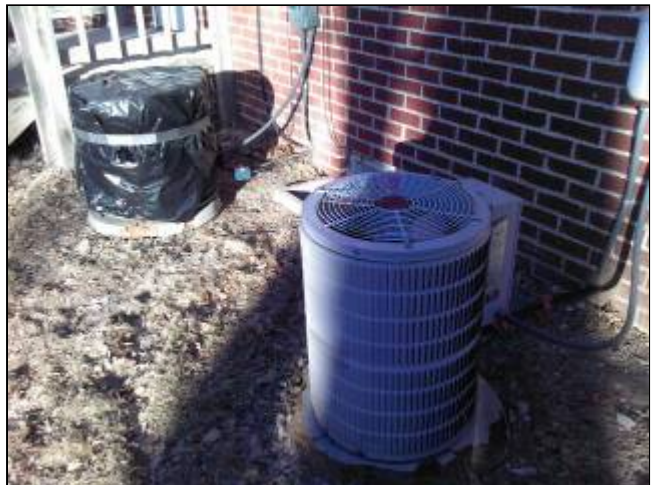
Outdoor temperature has been less than 60 degrees within the last 24 hours, preventing safe operation of A/C system (turning on A/C in cold weather may damage internal components). Unable to visually verify components condition. Due to age of furnace units, Recommend having unit maintenance performed to ensure maximum efficiency and useful life. Units concealed, unable to determine mfg date. Only open unit is 1988. Budget for future replacement.

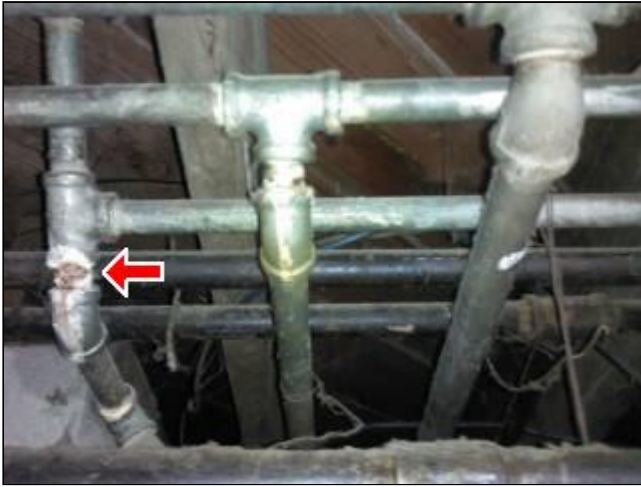
10.3 Picture 1

Majority of distribution piping is of galvanized steel construction. Typically, over time this piping will have its water flow reduced by corrosion build-up and leaking joints. None visible during time of inspection. Recommend contracting licensed plumber to evaluate and repair/replace areas as necessary to facilitate proper system performance and increase safe water usage.

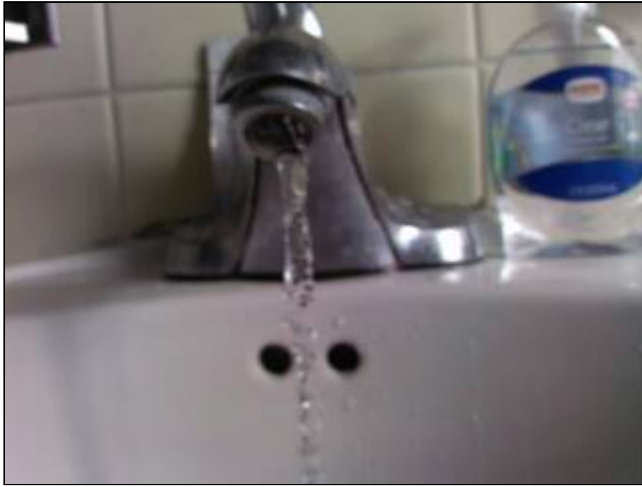
11.0 Picture 1

Low flow noted in all units. (pressure most likely due to mineral build up in piping). This condition may be caused by installed Galvanized piping system. Recommend contracting licensed plumber to thoroughly investigate and replace galvanized areas as necessary, including plumbing section coming in from curb stop, to restore proper system performance.
