PROPERTY CONDITION REPORT

CLIENT: Joe Howell
PROPERTY ADDRESS: 210 N 32nd Ave
Omaha NE
AGENT: Morrie Korthals
DATE: 1/28/2014
INSPECTOR: Adam Staab
REPORT #: 210_4

Report# 210_4
210 N 32nd Ave
Omaha NE
Dear Joe,

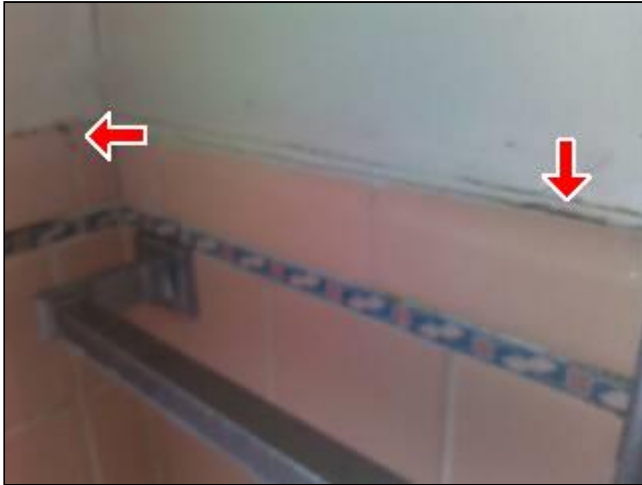
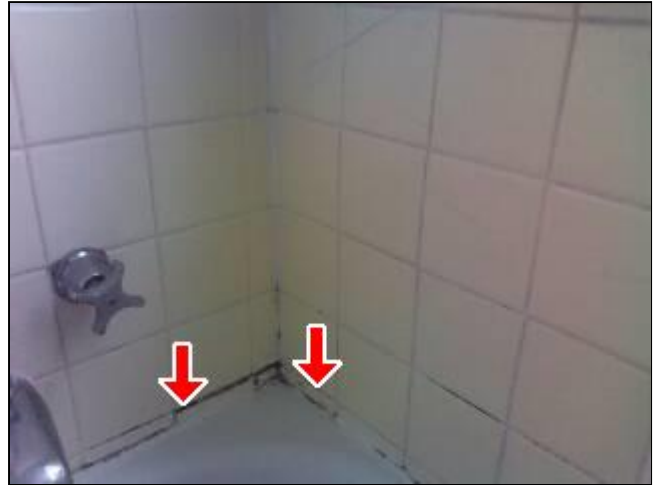
Deteriorated caulking at ceramic tiles within showers throughout units. This will allow water to penetrate underlying framing areas and spread associated damages. Recommend removing deteriorated caulking and properly re-caulking to reduce possible moisture penetration and associated damages. None visible during time of inspection.

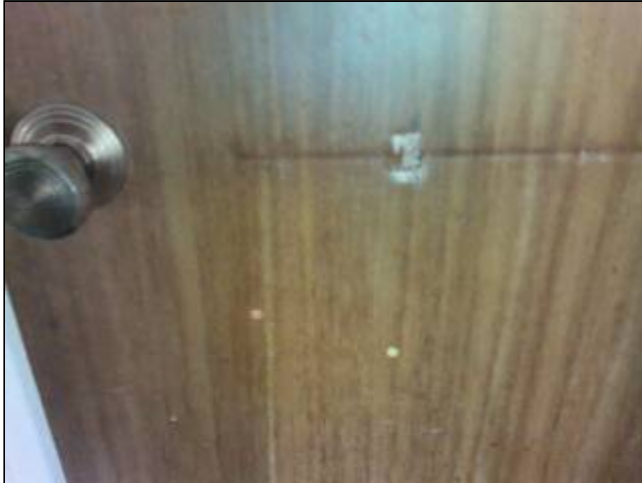
24.4 Picture 1

Damaged closet door at unit 3.
